Town of Greentown, Indiana  
Greentown Stormwater  
Master Plan

## **APPENDIX B**

### **PHOTO LOG**

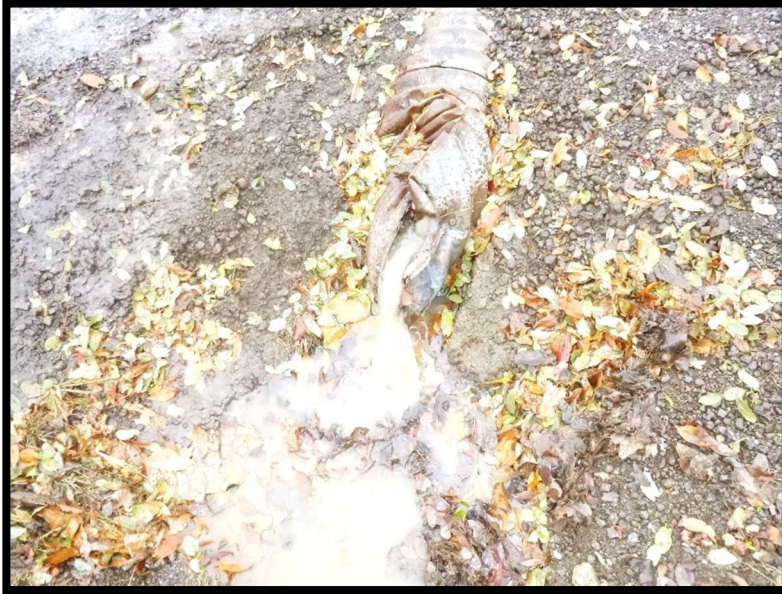
**Photo No. 17**

Damaged downstream end  
of ~12" driveway culvert

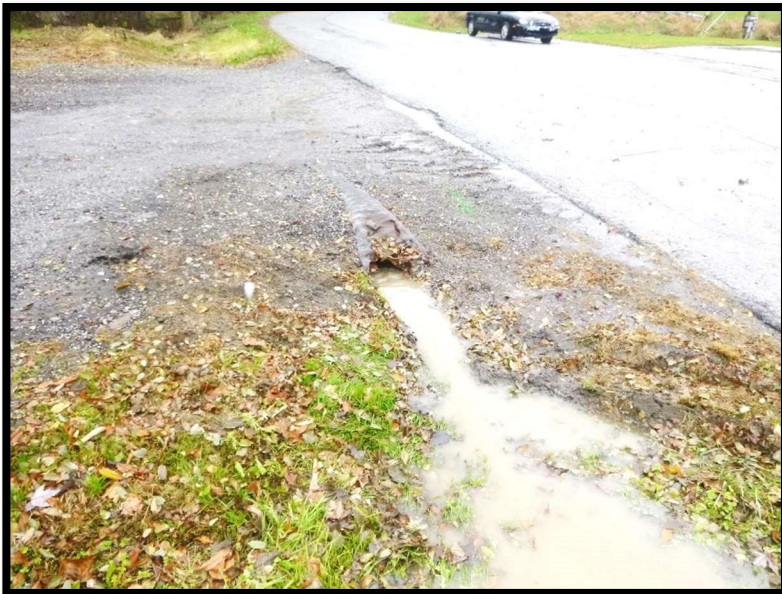
**Photo No. 18**

Damaged upstream end of  
~12" driveway culvert

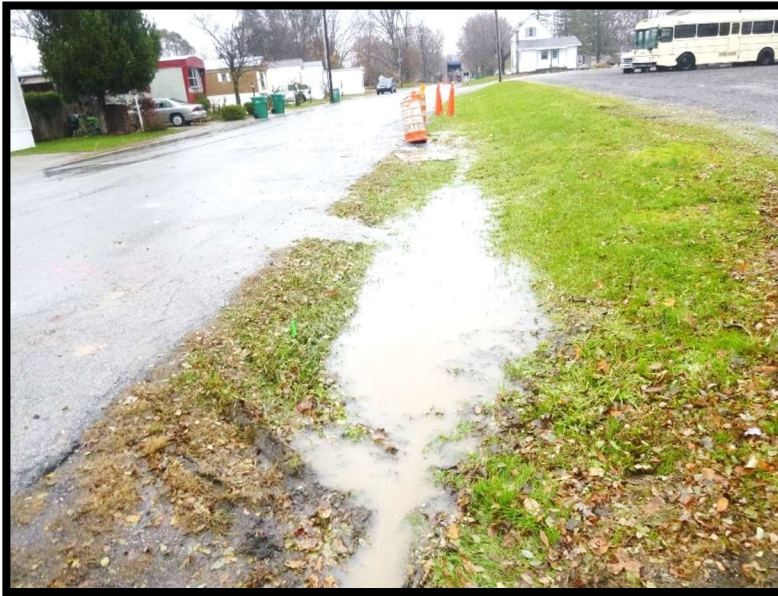
**Photo No. 19**

Ponding water upstream of  
damaged ~12" driveway  
culvert

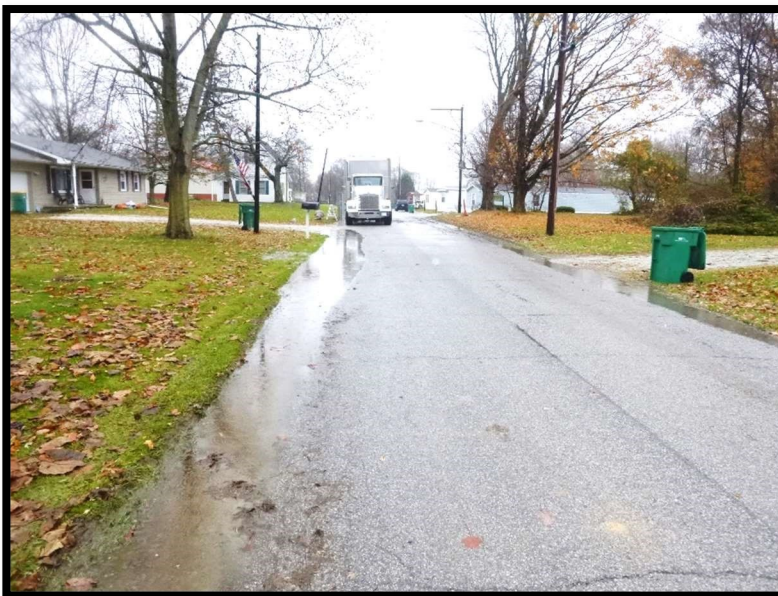
**Photo No. 20**

Ponding water on both side  
of Payton St. and in  
driveway approaches

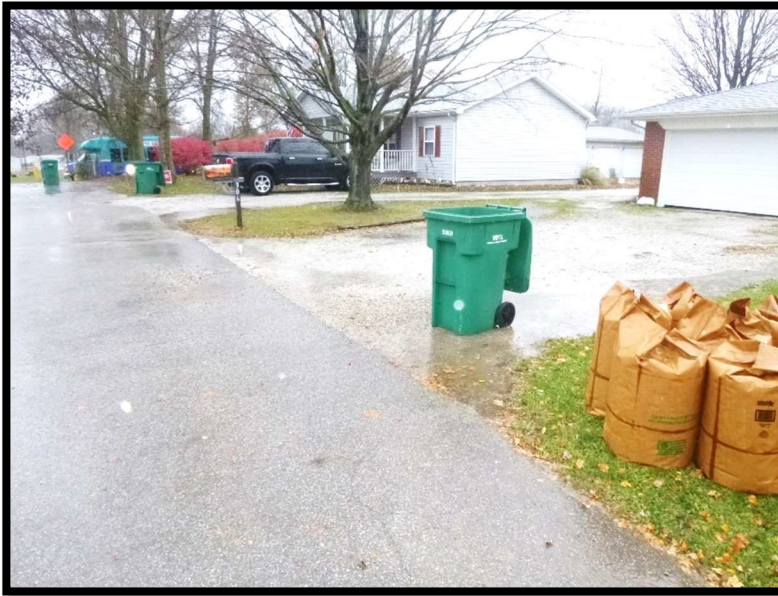
**Photo No. 23**

Ponding water in driveway

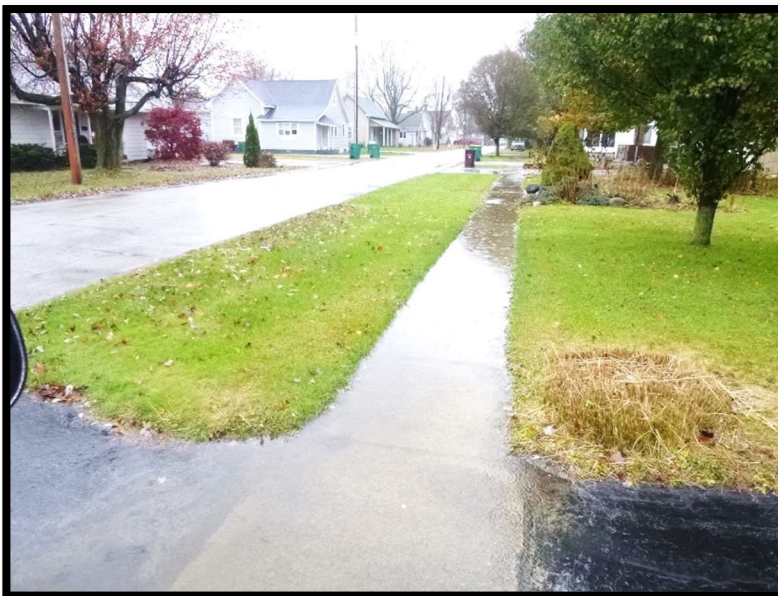
**Photo No. 24**

Ponding water on east  
sidewalk

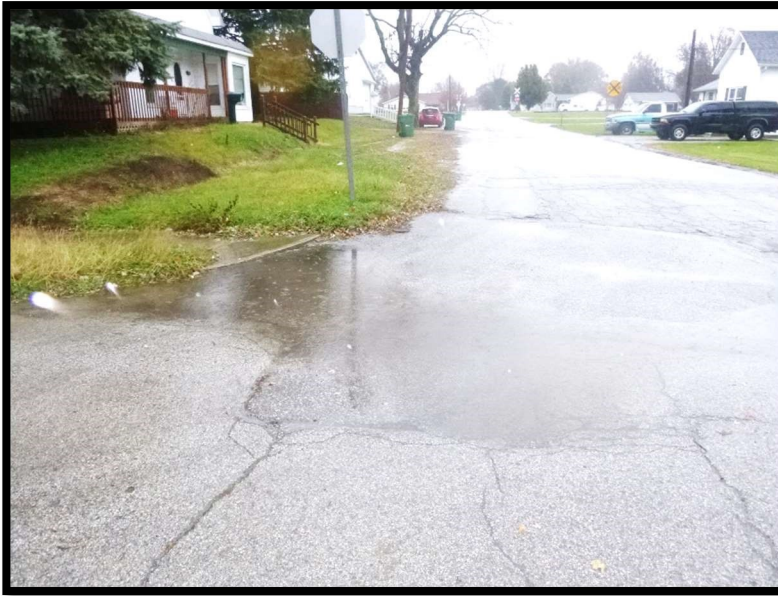
**Photo No. 33**

Ponding water in  
intersection

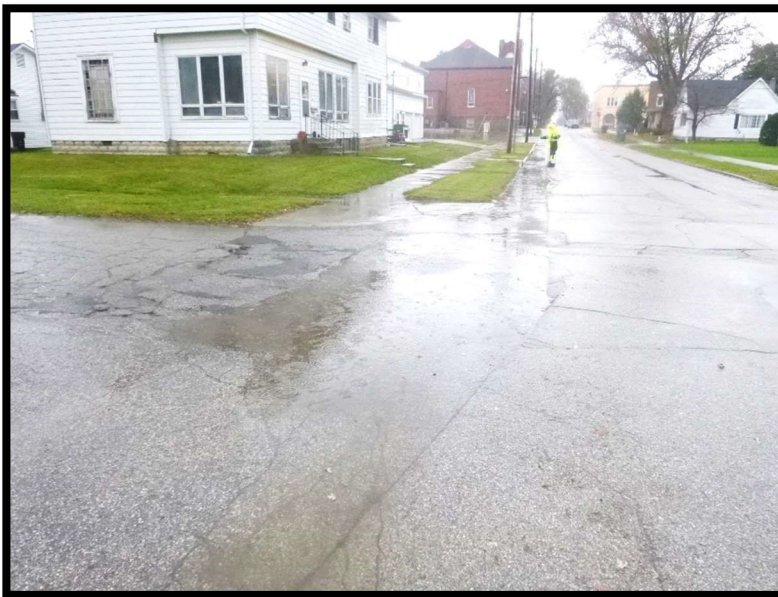
**Photo No. 34**

Ponding water in  
intersection

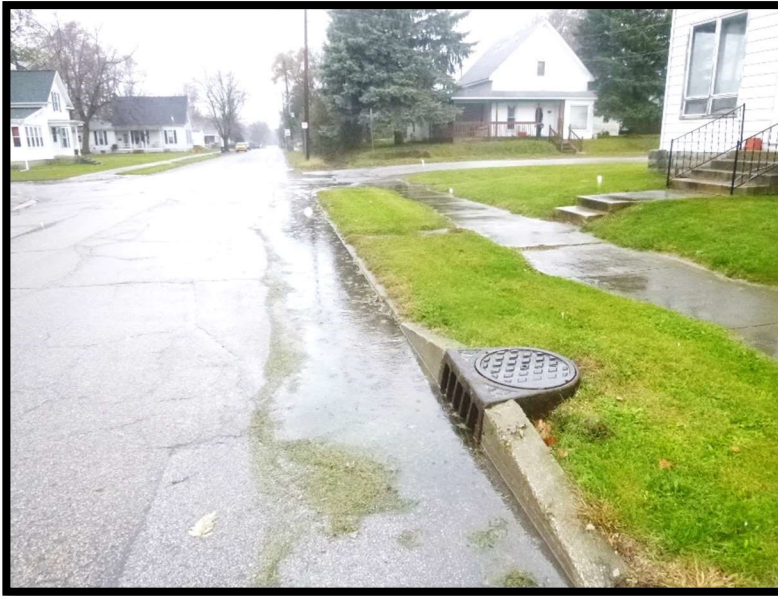
**Photo No. 35**

Ponding water in  
intersection along curb to  
next inlet

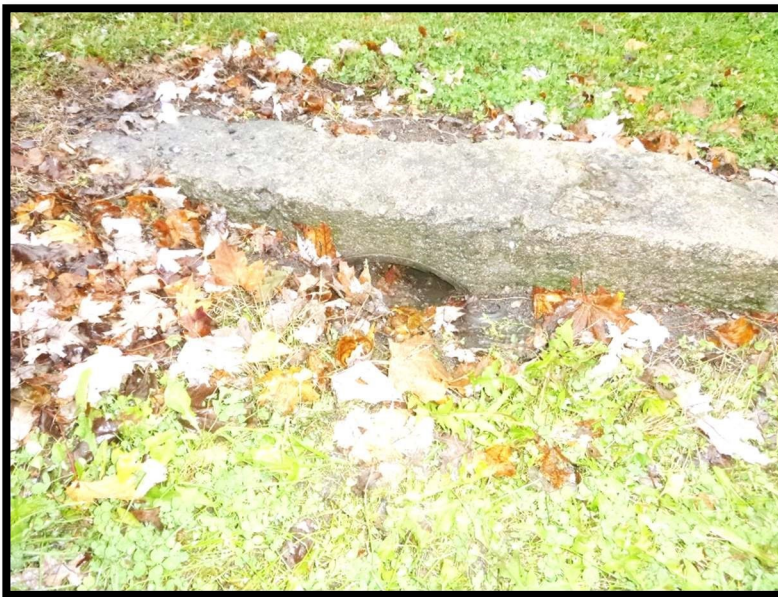
**Photo No. 40**

Evidence of previous  
culvert crossing Harrison St.  
now more than half full of  
sediment

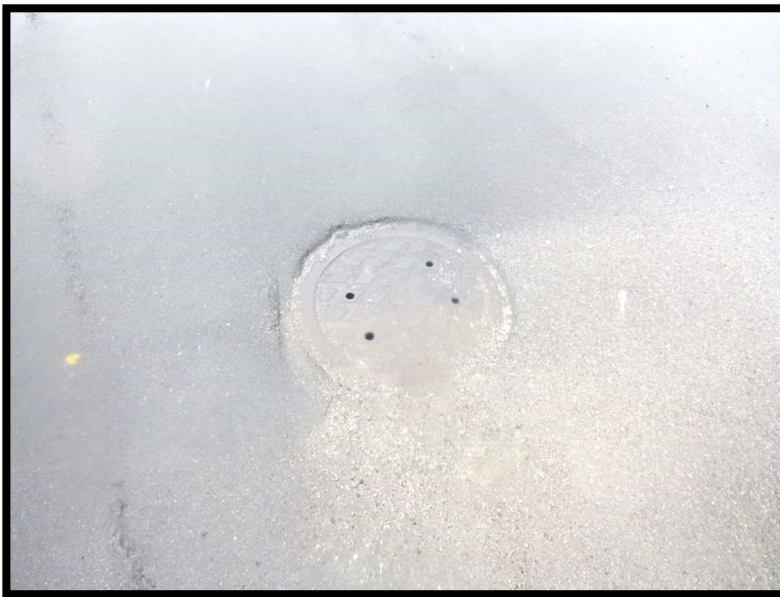
**Photo No. 48**

Ponding water around  
sanitary manhole with a  
solid lid casting

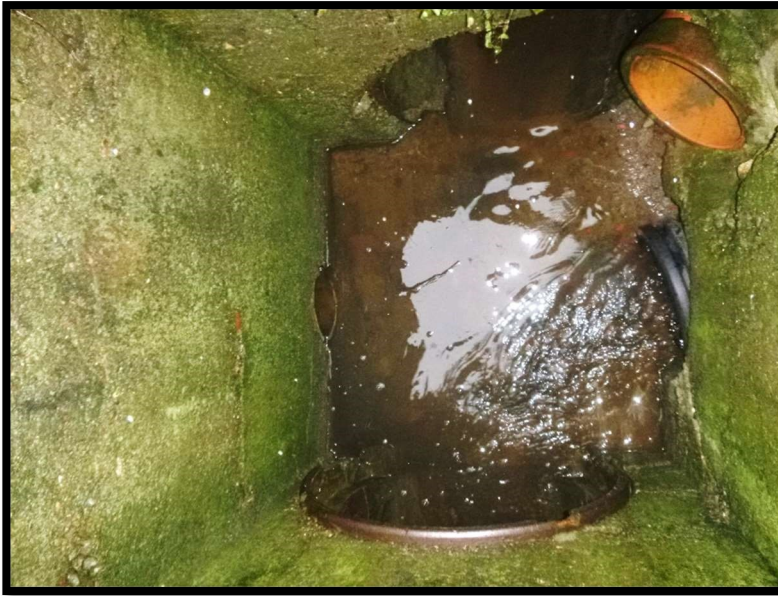
**Photo No. 73**

Main manhole draining  
storm sewer system north of  
railroad, possible bottleneck  
in system, out pipe at  
6 o'clock to the south

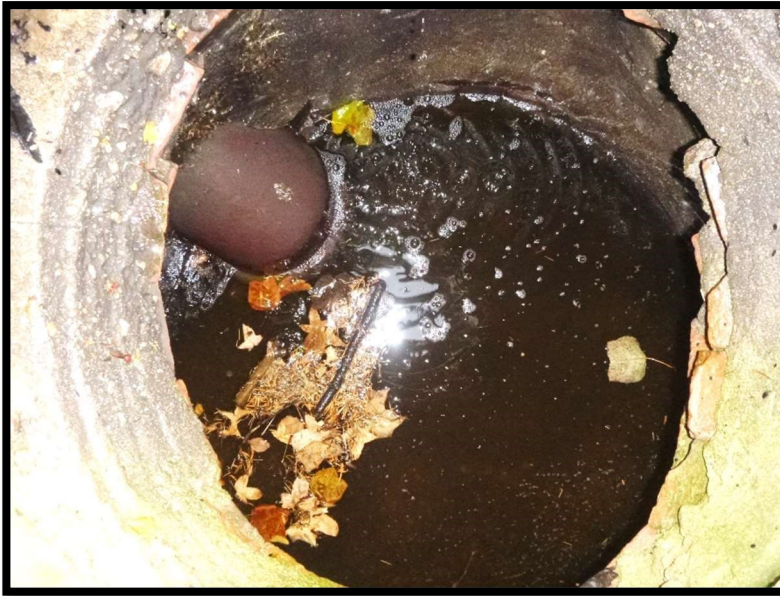
**Photo No. 83**

Curb inlet full of debris, out  
pipe buried, 48-inch pipe  
downstream

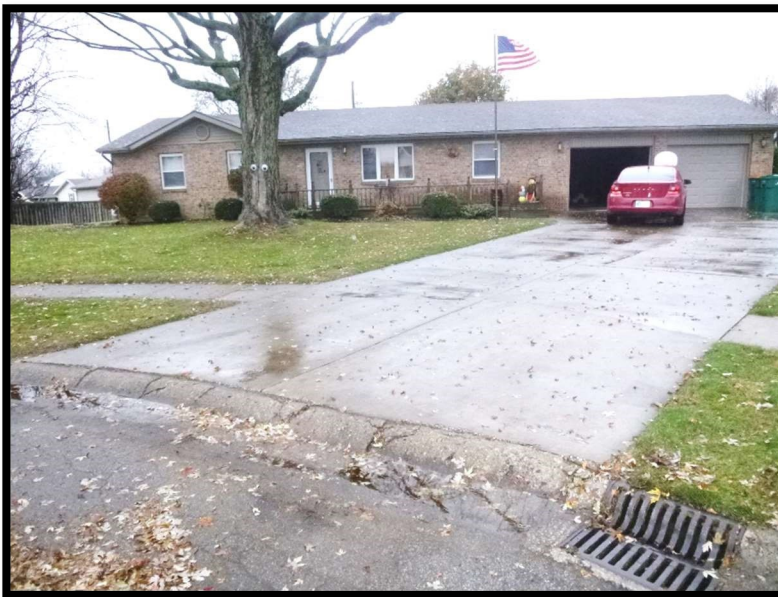
**Photo No. 88**

Debris at driveway entrance, evidence of ponding water next to inlet
