Town of Greentown, Indiana  
Greentown Stormwater  
Master Plan

## **APPENDIX B**

### **PHOTO LOG**

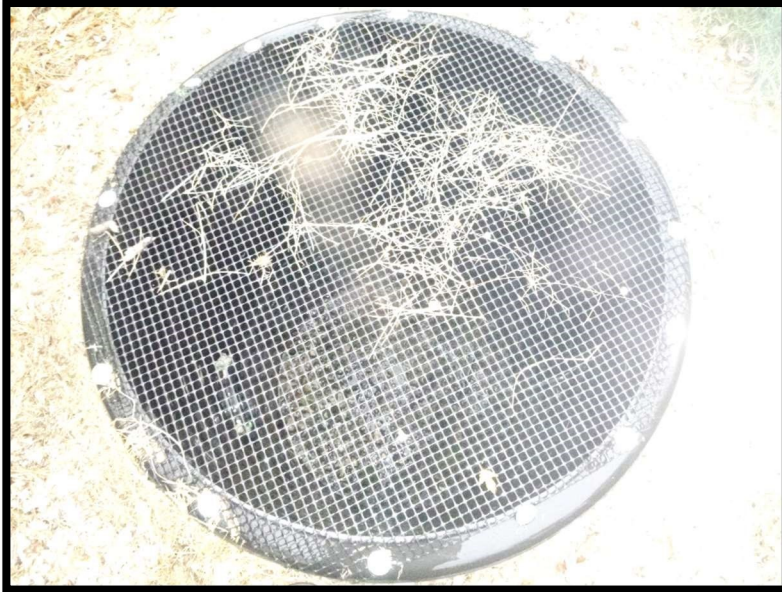
### Photo No. 1

Dry well in detention pond  
behind new Dollar General  
development

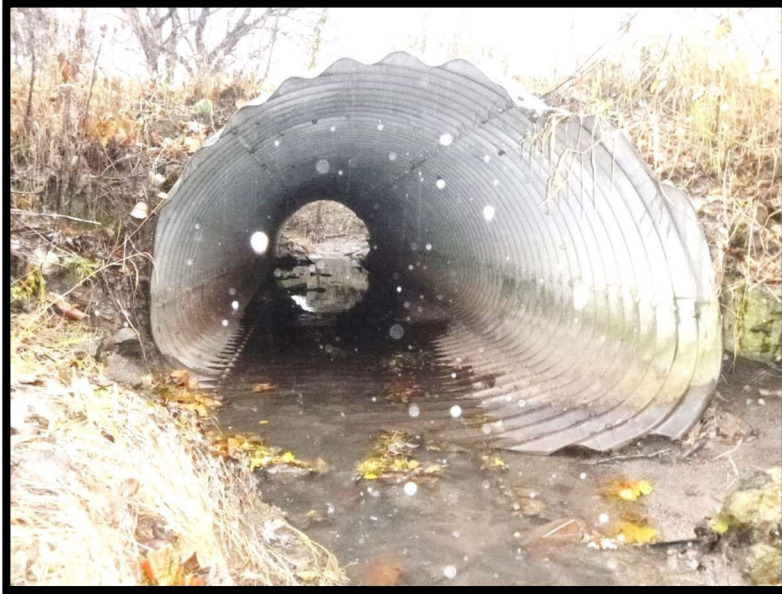
**Photo No. 9**

6' X 8.5' culvert, J Loop  
crossing Carter St. looking  
upstream

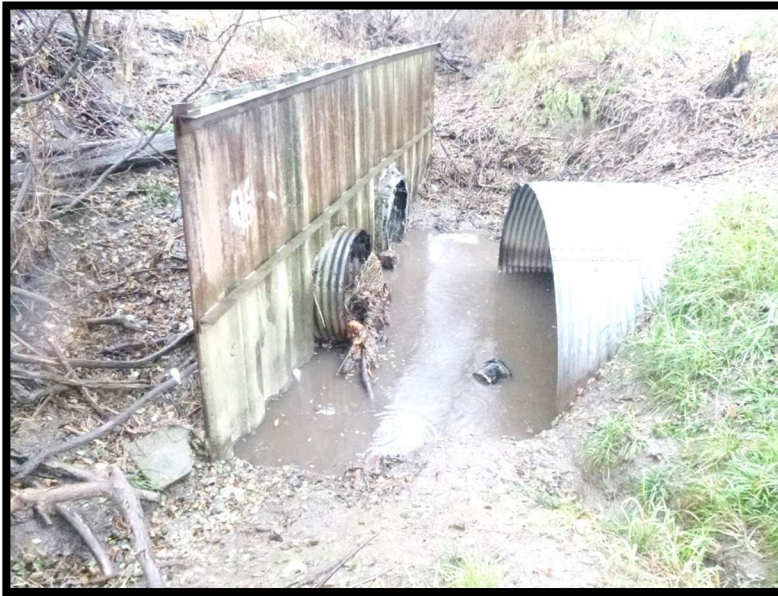
**Photo No. 11**

6' X 10' culvert crossing  
Payton St. upstream to twin  
42" culverts crossing  
railroad downstream

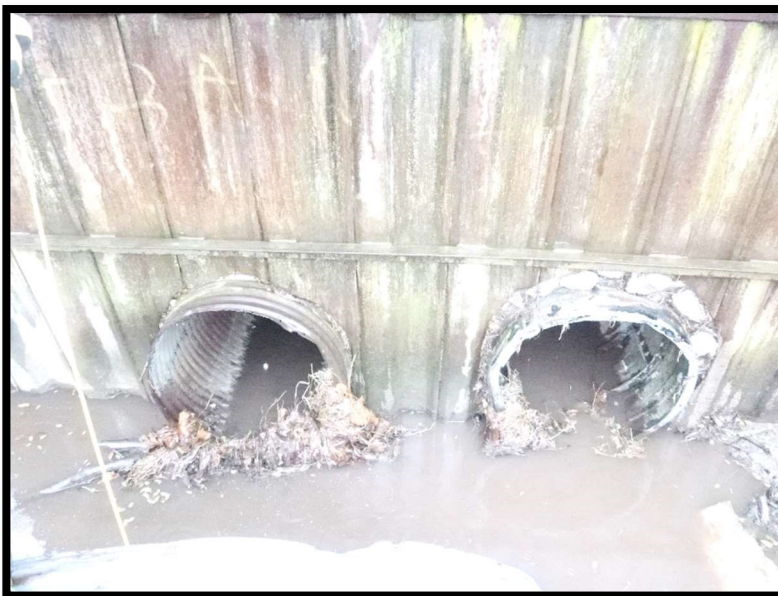
**Photo No. 12**

Twin 42" culverts crossing  
railroad downstream

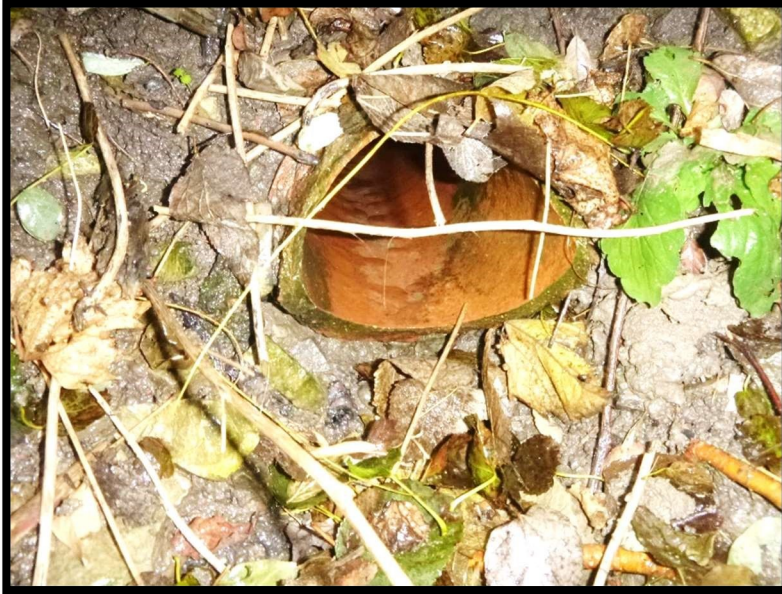
**Photo No. 13**

6" drain outfall to railroad  
culverts

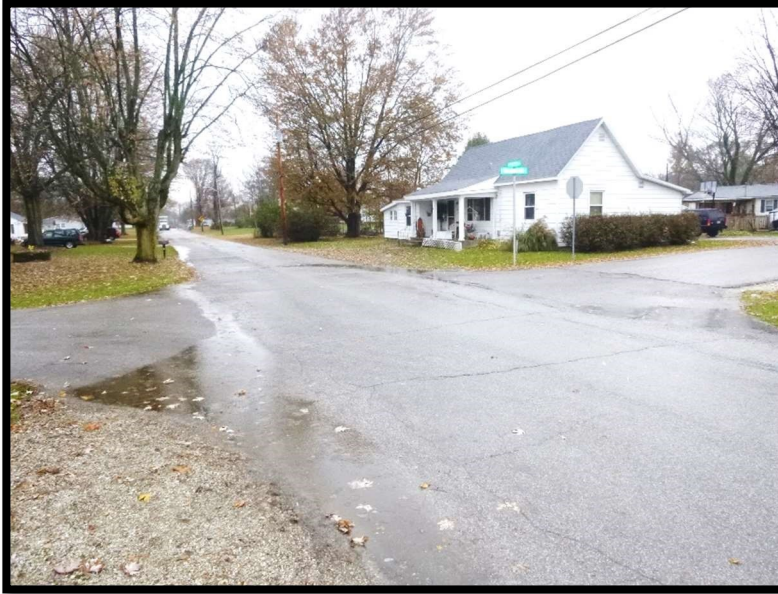
**Photo No. 21**

Ponding water in  
intersection

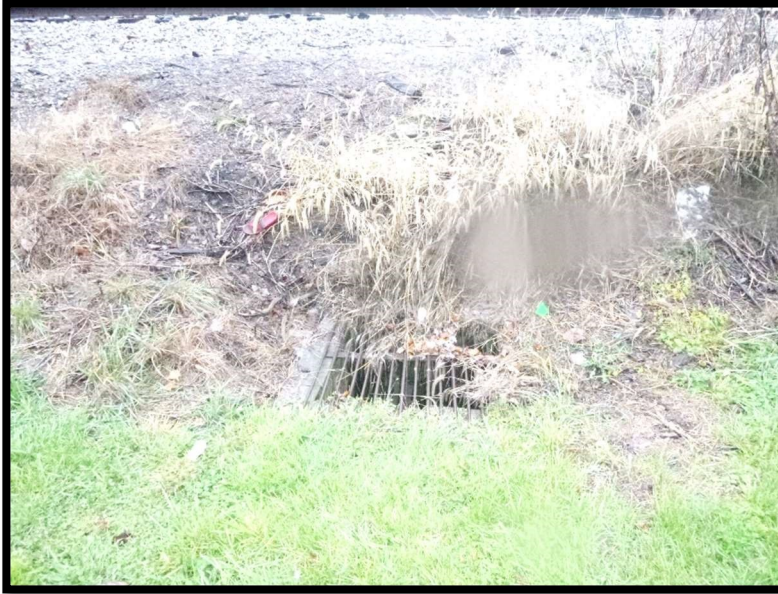
**Photo No. 25**

Main manhole draining  
storm sewer system north of  
railroad, possible bottleneck  
in system

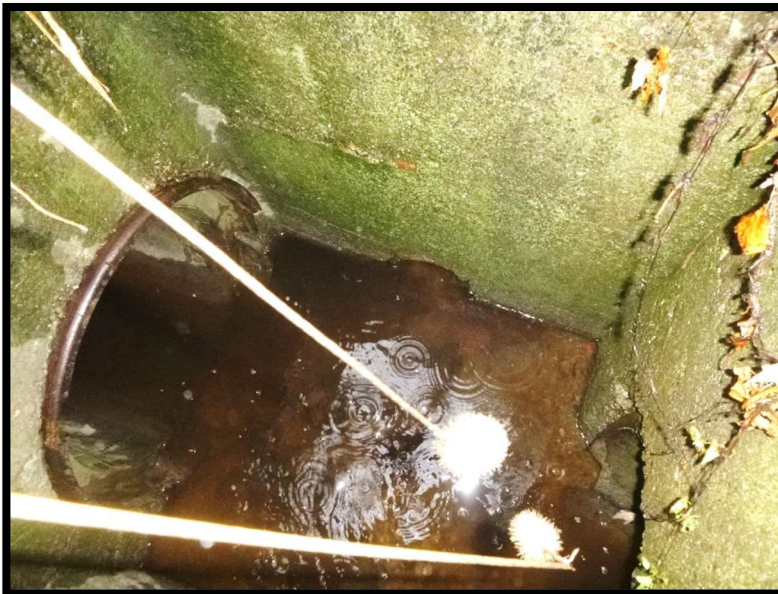
**Photo No. 26**

Main manhole draining  
storm sewer system north of  
railroad, possible bottleneck  
in system

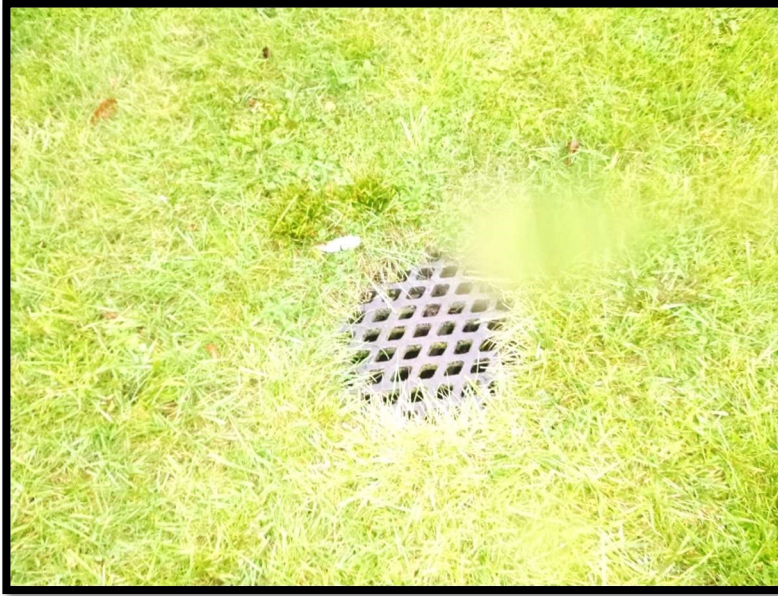
**Photo No. 27**

Another inlet draining back of Blondie's Cookies' property that ties into main manhole north of railroad

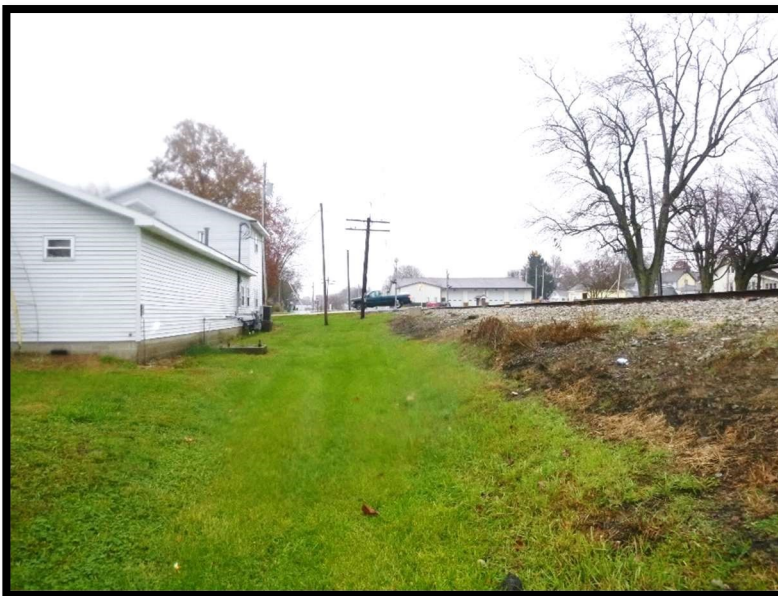
**Photo No. 28**

Ditch between railroad and Blondie's Cookies draining to main manhole north of railroad

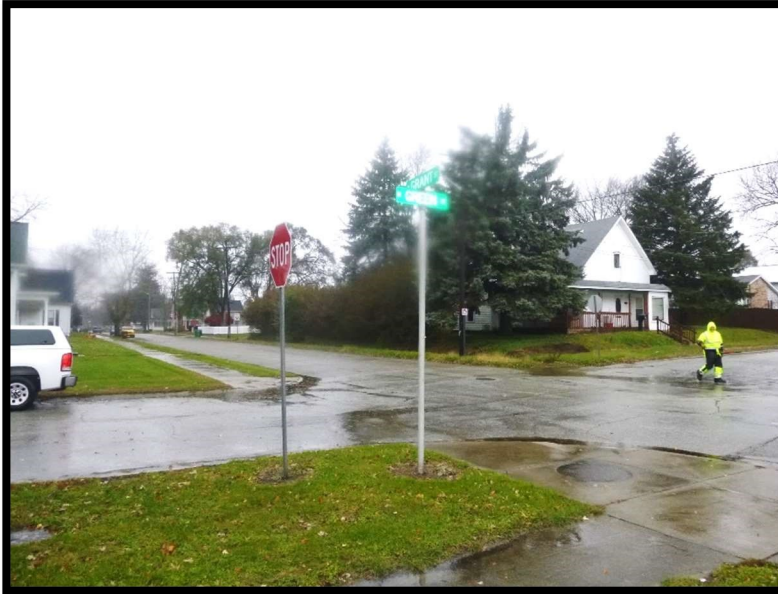
**Photo No. 31**

Ponding water in  
intersection

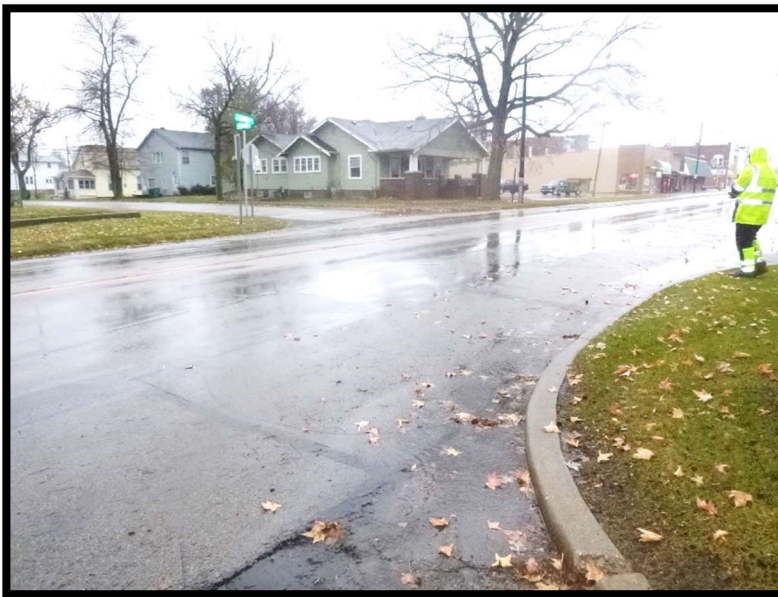
**Photo No. 36**

Ponding water in  
intersection

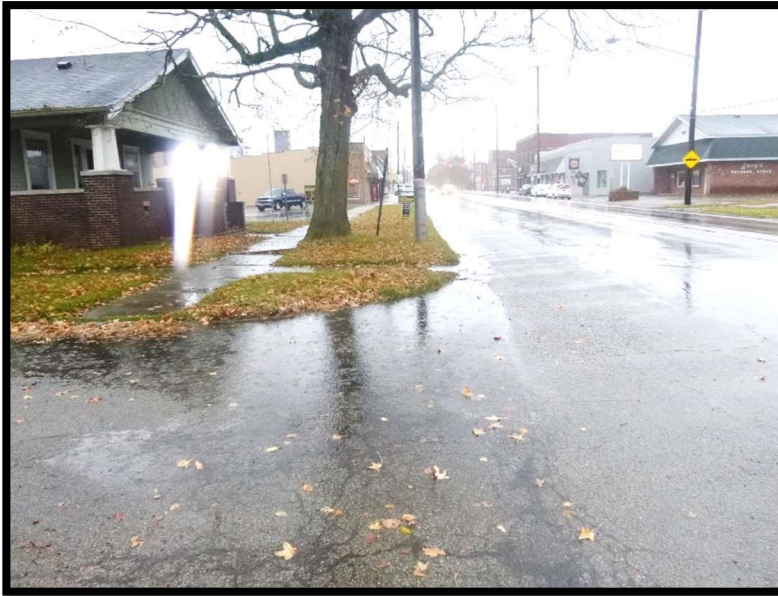
**Photo No. 37**

Ponding water in  
intersection

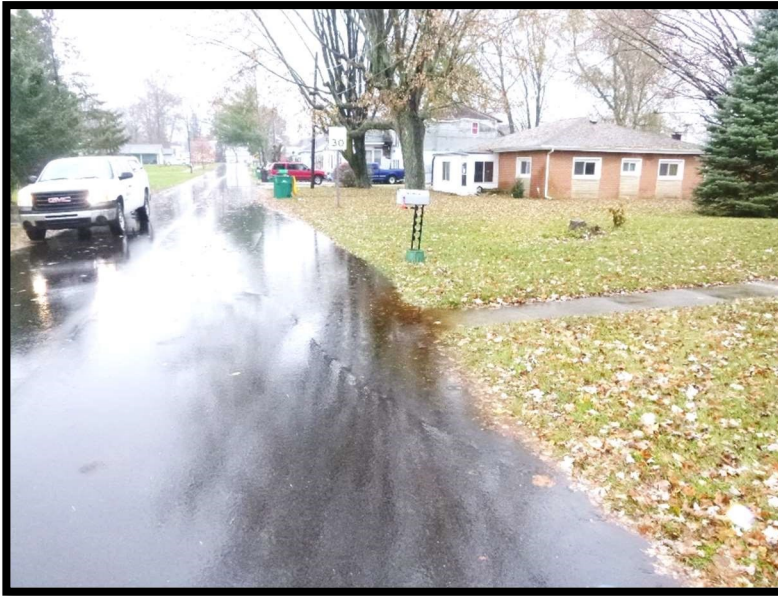
**Photo No. 39**

Ponding water in street

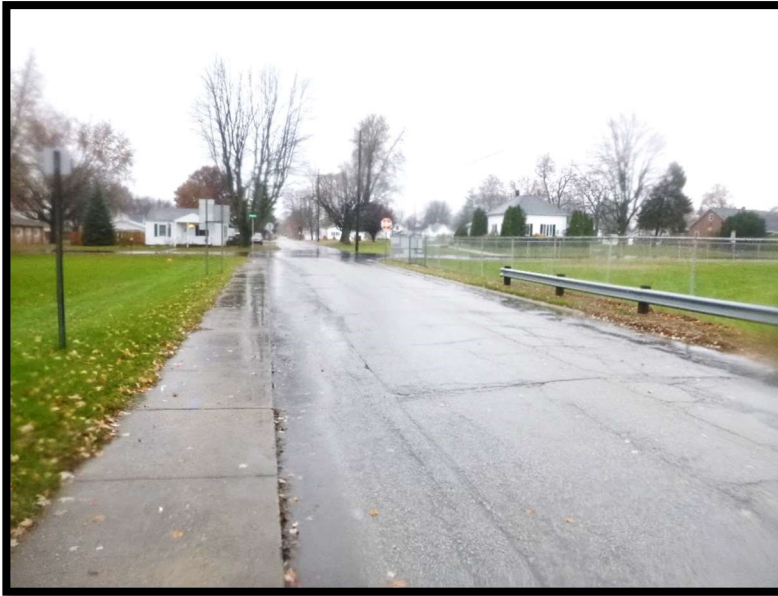
**Photo No. 41**

Ponding water in street

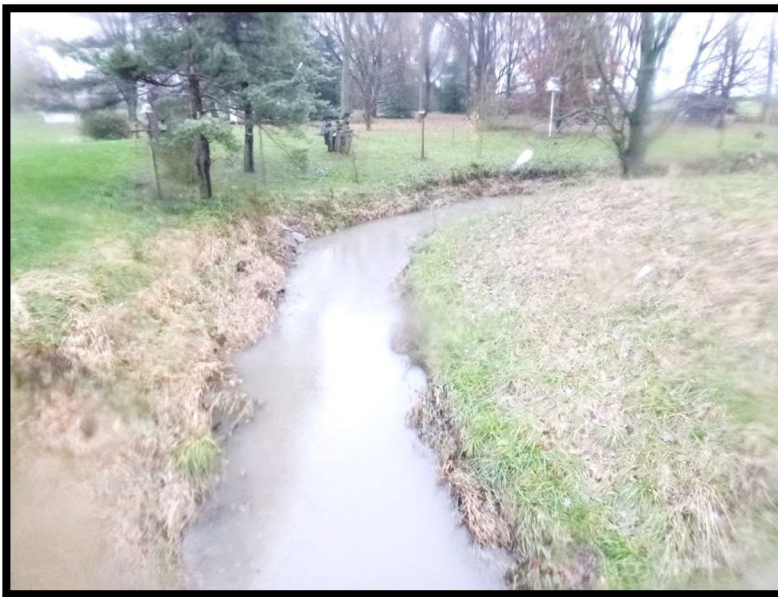
**Photo No. 42**

Henry Brunk crossing  
Meridian St., looking  
upstream

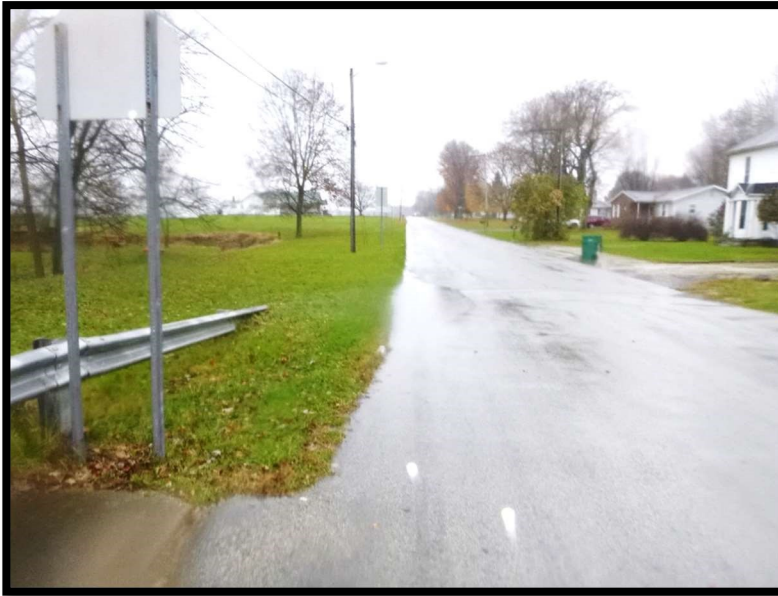
**Photo No. 43**

Some ponding water in  
street

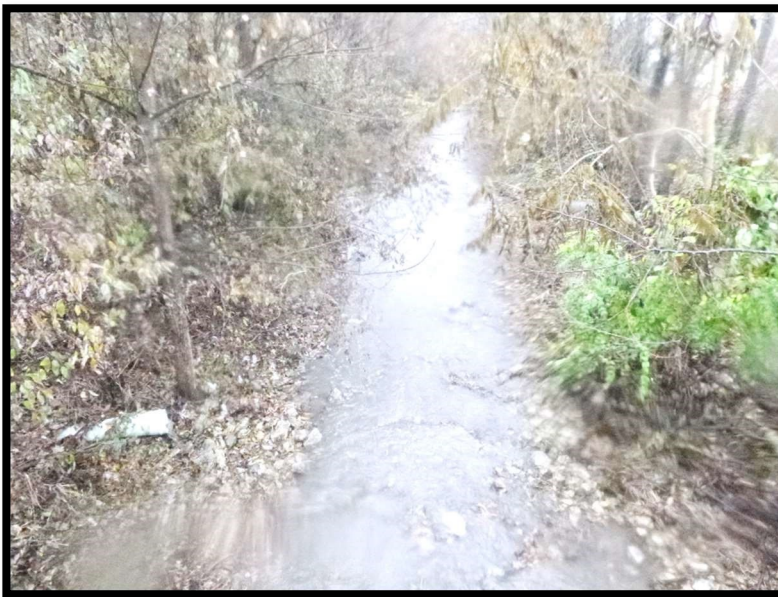
**Photo No. 44**

Henry Brunk crossing  
Meridian St., looking  
downstream

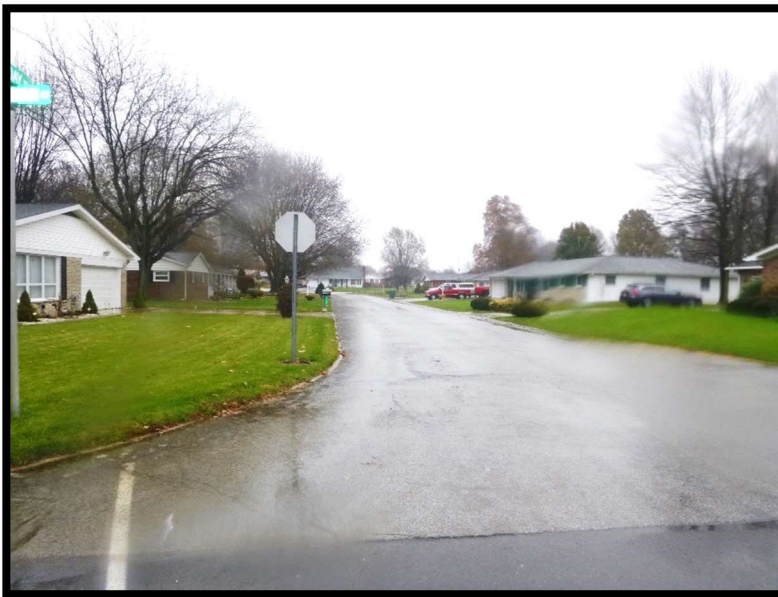
**Photo No. 46**

Ponding water in  
intersection

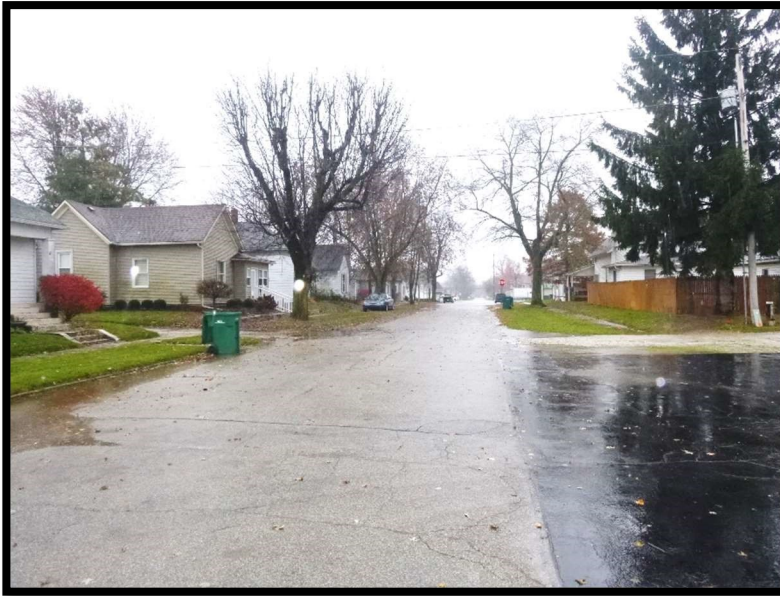
**Photo No. 49**

Ponding water along street

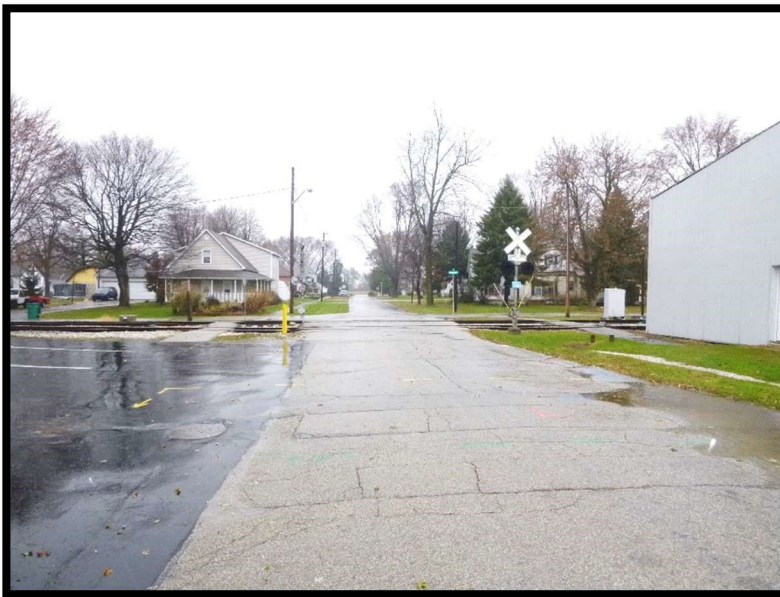
**Photo No. 50**

Ponding water along street

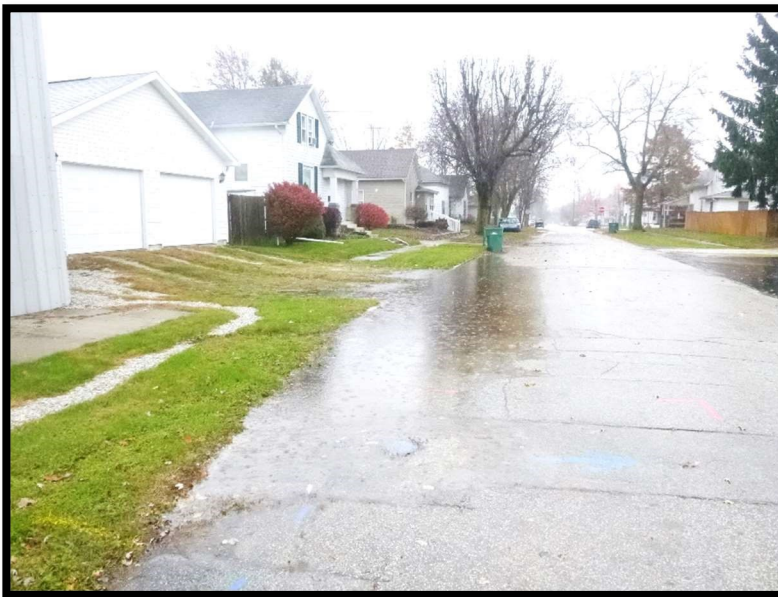
**Photo No. 52**

Ponding water in driveway  
and street

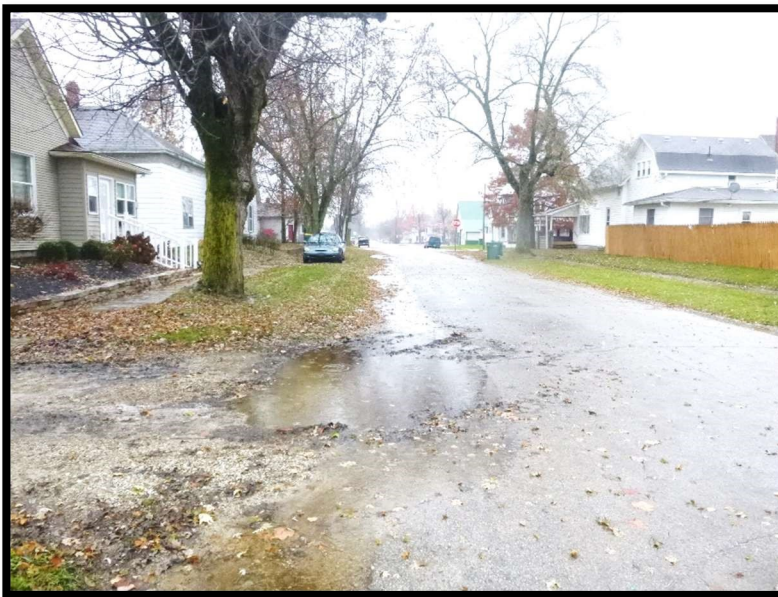
**Photo No. 54**

Ponding water in low spot  
of driveway and east side of  
the street

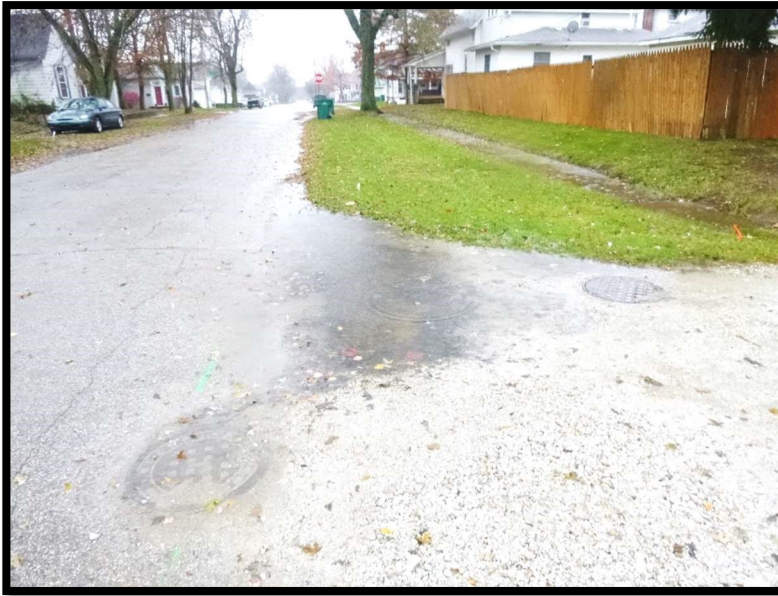
**Photo No. 55**

Ponding water in low spot  
of driveway and west side  
of the street

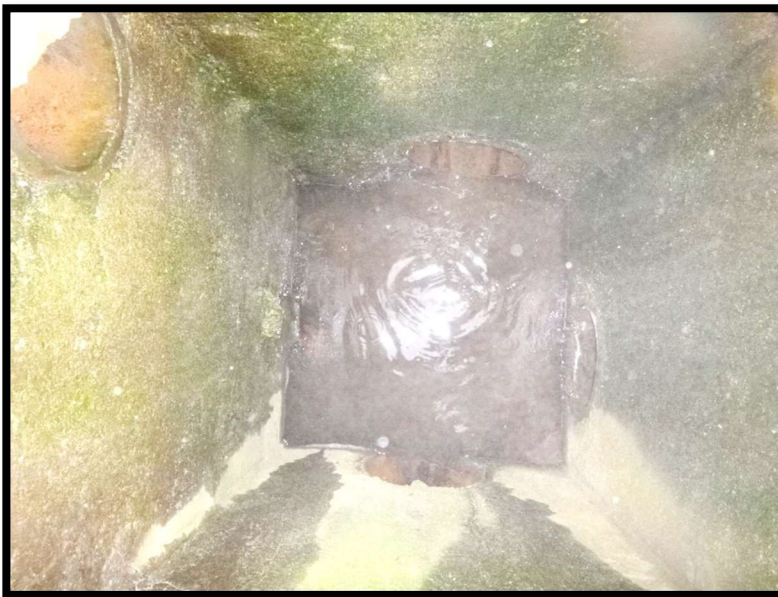
**Photo No. 56**

Existing condition of inlet  
structure

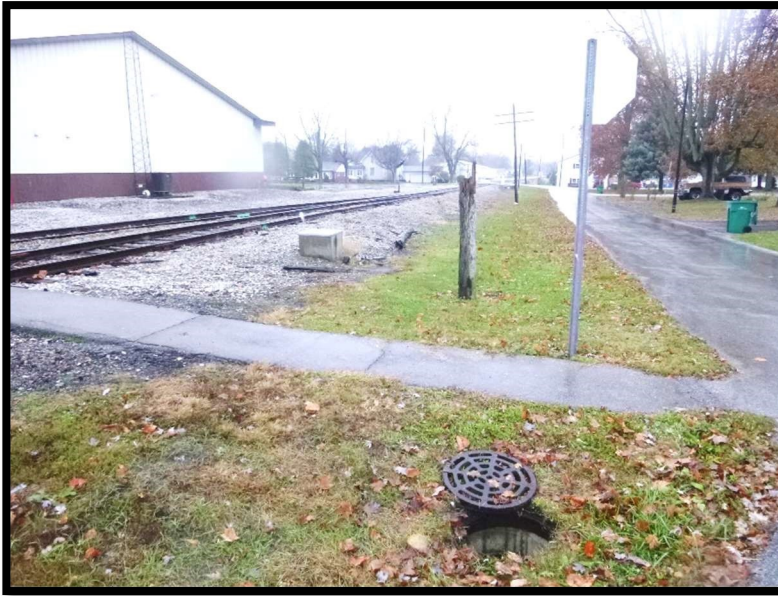
**Photo No. 57**

Existing condition of inlet  
structure, looking  
downstream

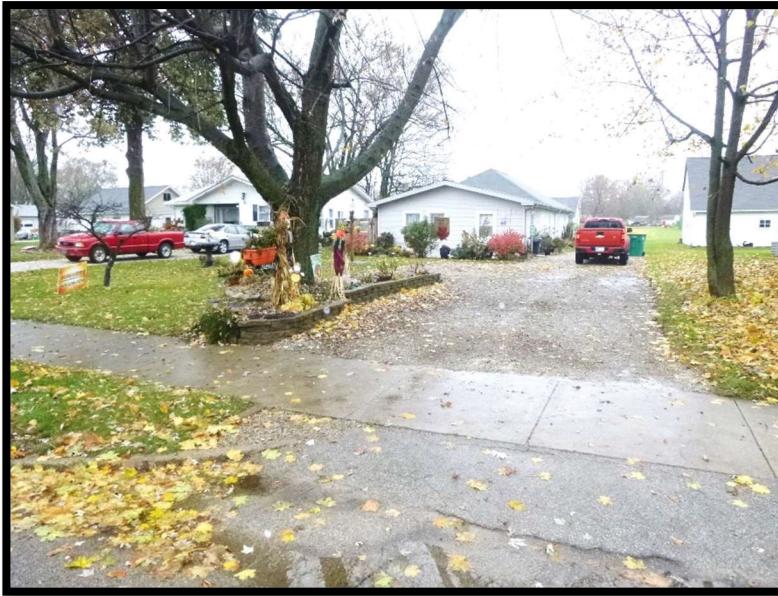
**Photo No. 67**

Property floods frequently

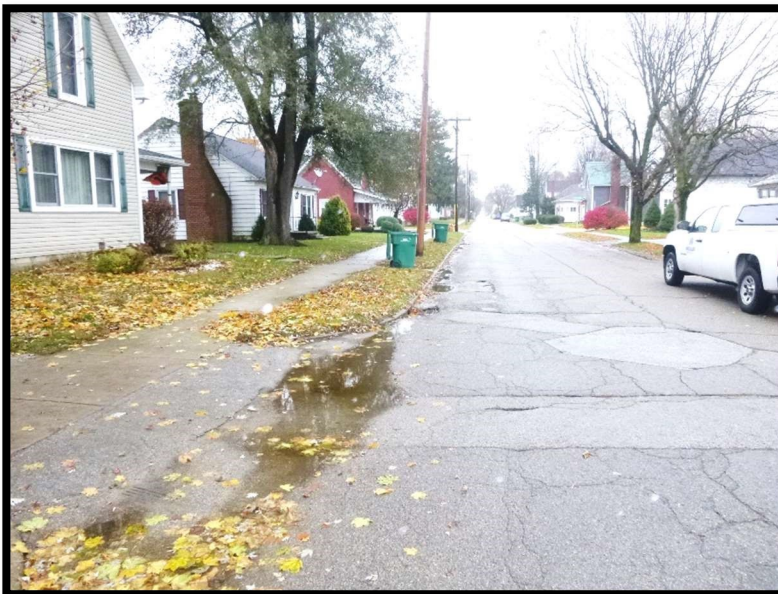
**Photo No. 68**

Ponding water in driveway

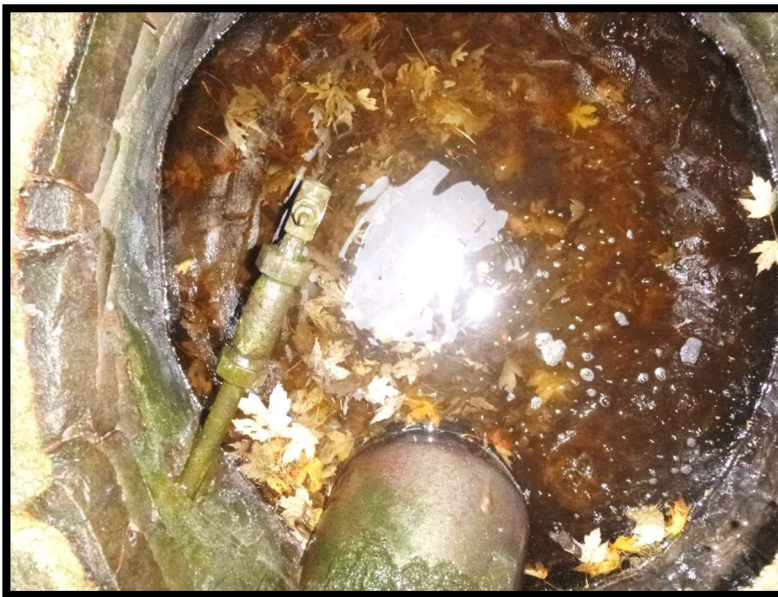
**Photo No. 74**

Curb inlet full of debris, out  
pipe buried

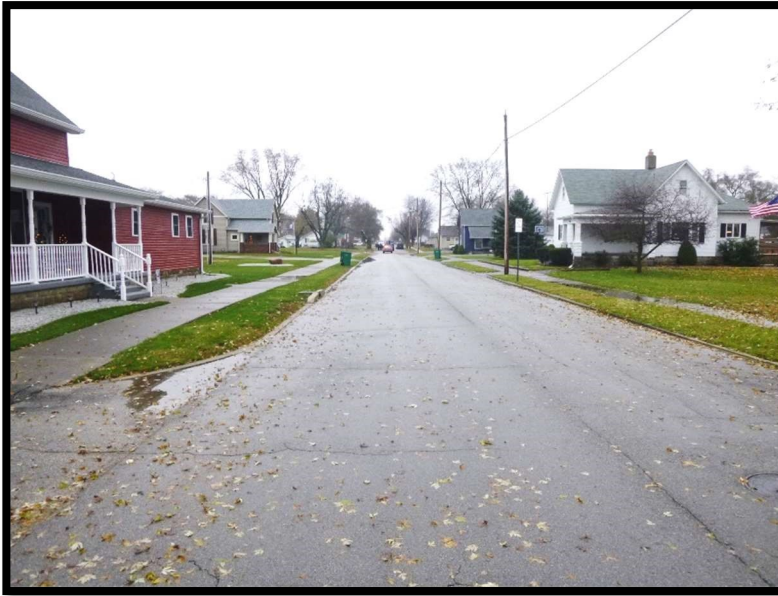
**Photo No. 75**

Some ponding water in  
intersection of Indiana St.  
and Grant St.

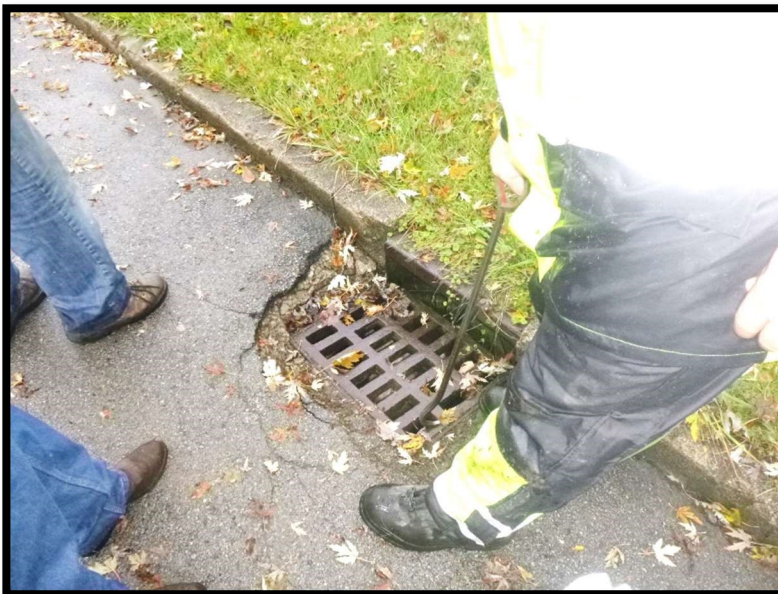
**Photo No. 76**

Inlet casting sunken a few  
inches below street

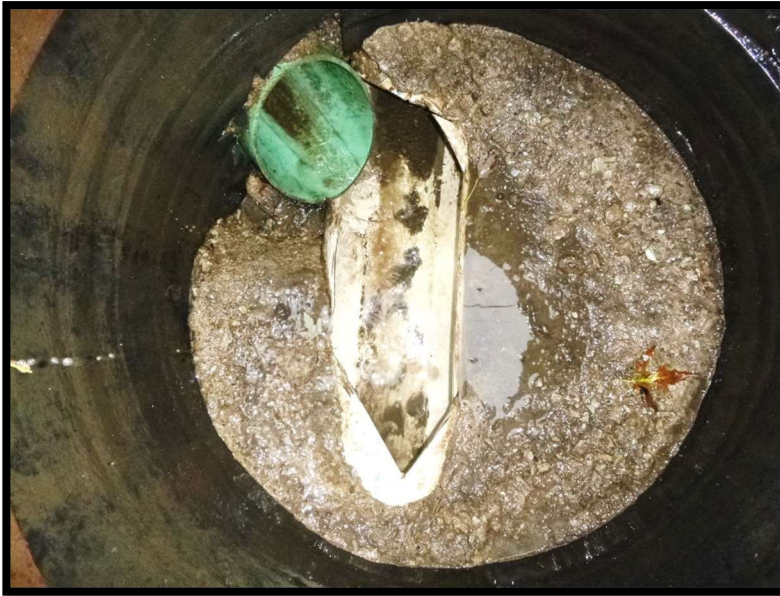
**Photo No. 77**

Undersized pipes through inlet

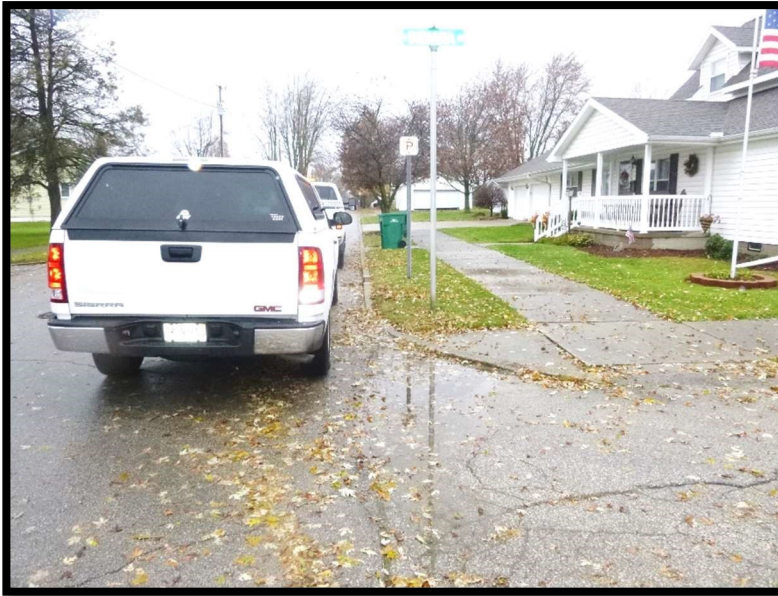
**Photo No. 79**

Ponding water in  
intersection

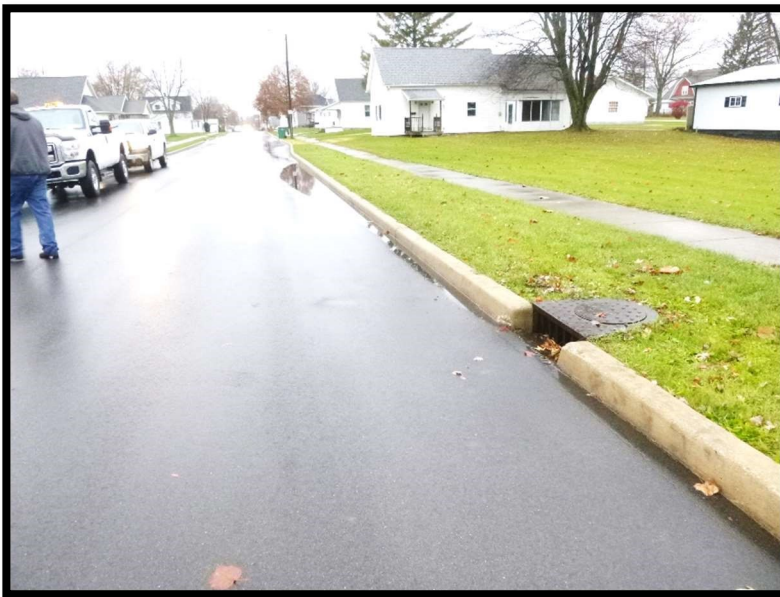
**Photo No. 84**

Curb inlet not located in low  
spot of Walnut St.

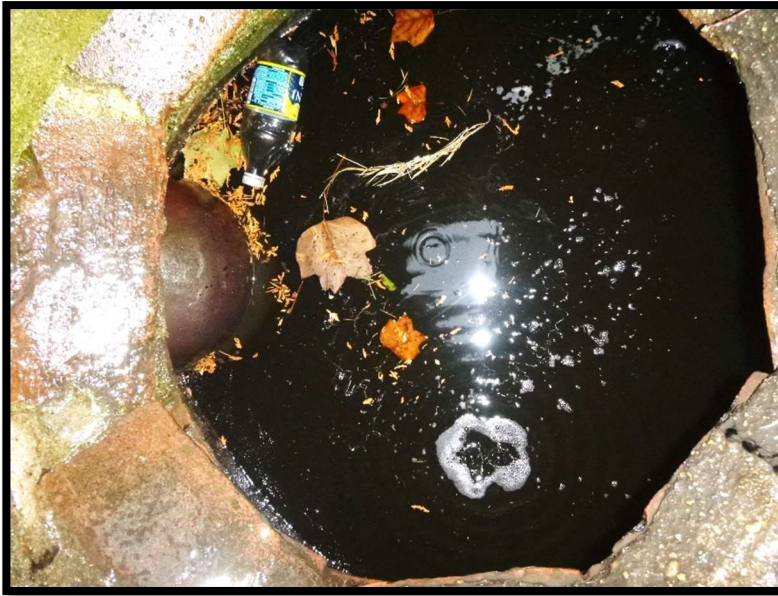
**Photo No. 85**

Curb inlet full of debris, out  
pipe buried, 48-inch pipe  
downstream

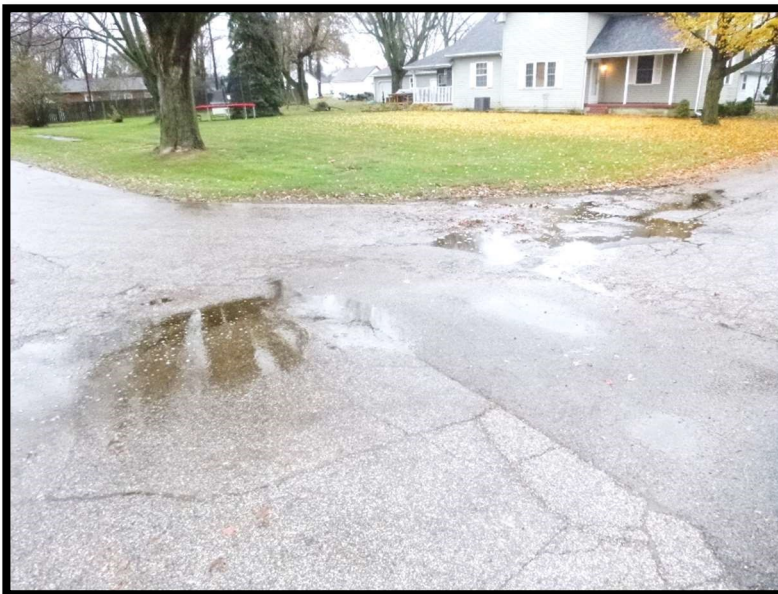
**Photo No. 86**

Ponding water in  
intersection

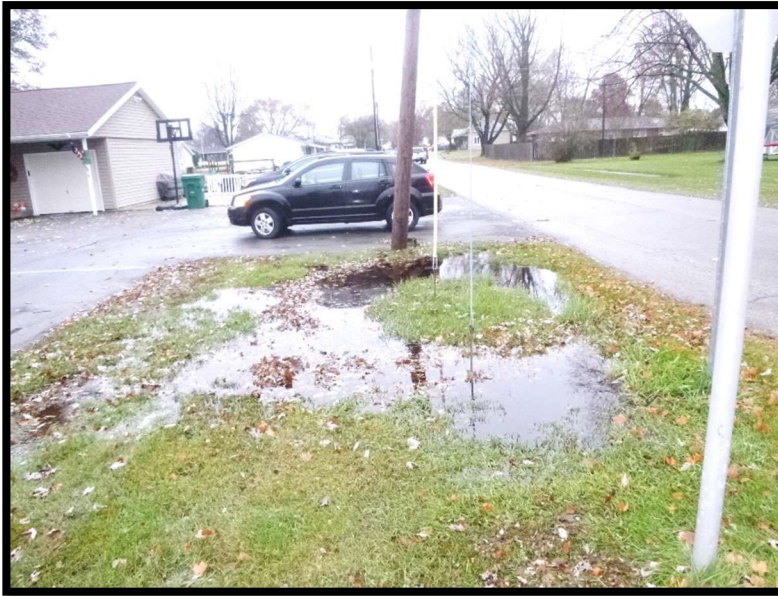
**Photo No. 87**

Ponding water in low spots of yard, may be addressed by eliminating low spots

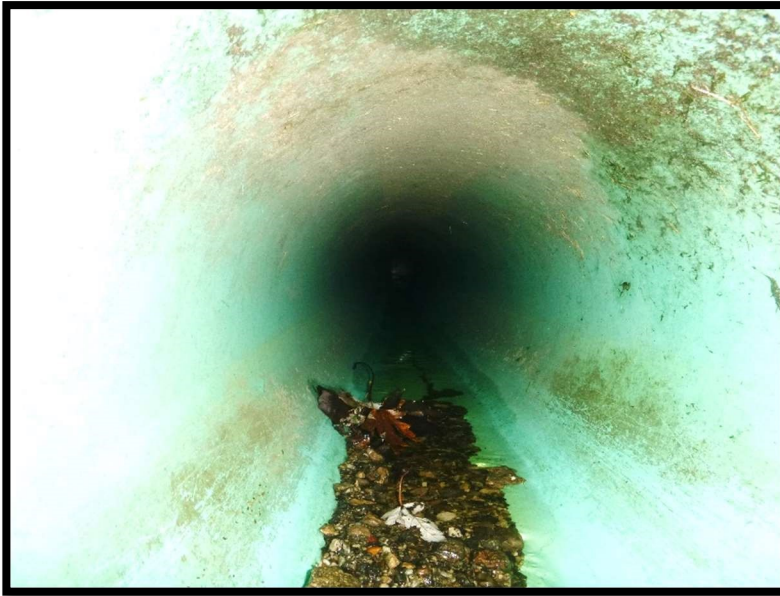
**Photo No. 89**

18-inch pipe out from inlet  
in cul-de-sac, clear of debris

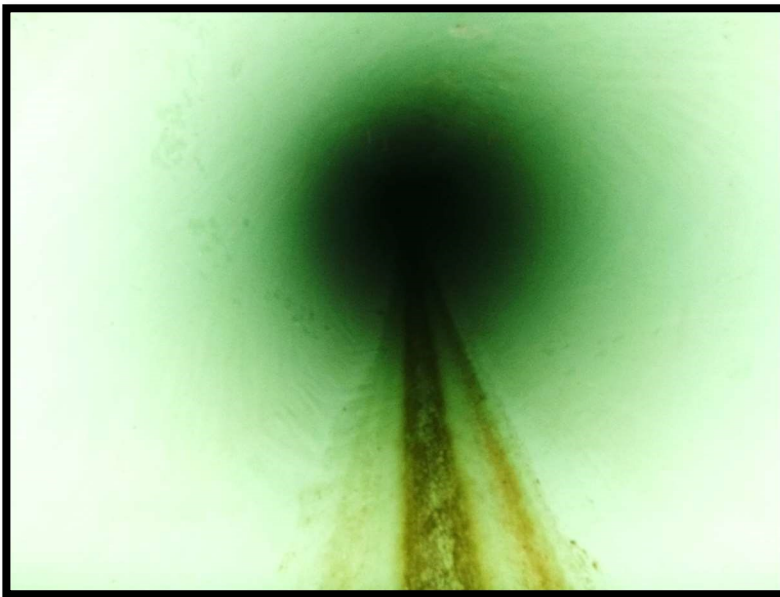
**Photo No. 90**

18-inch pipe out from inlet  
in cul-de-sac, clear of debris

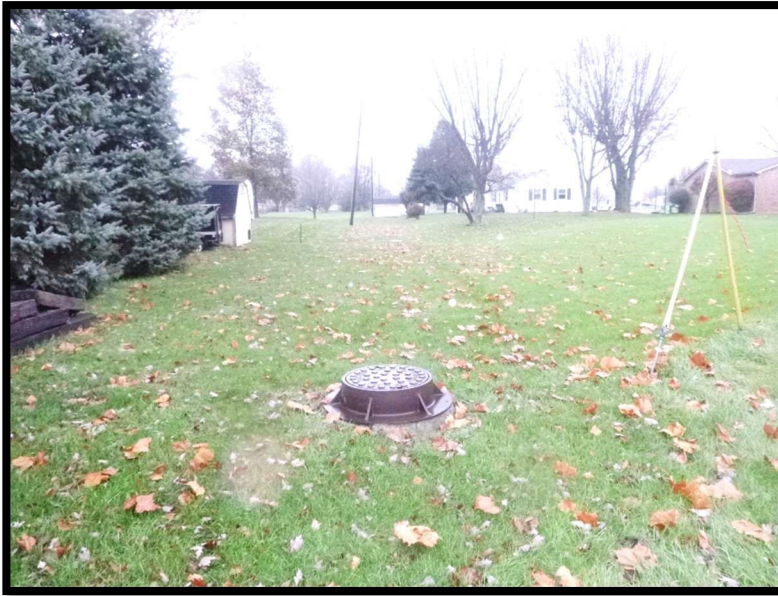
**Photo No. 91**

In backyard along storm  
sewer path, parallel to  
sanitary sewer

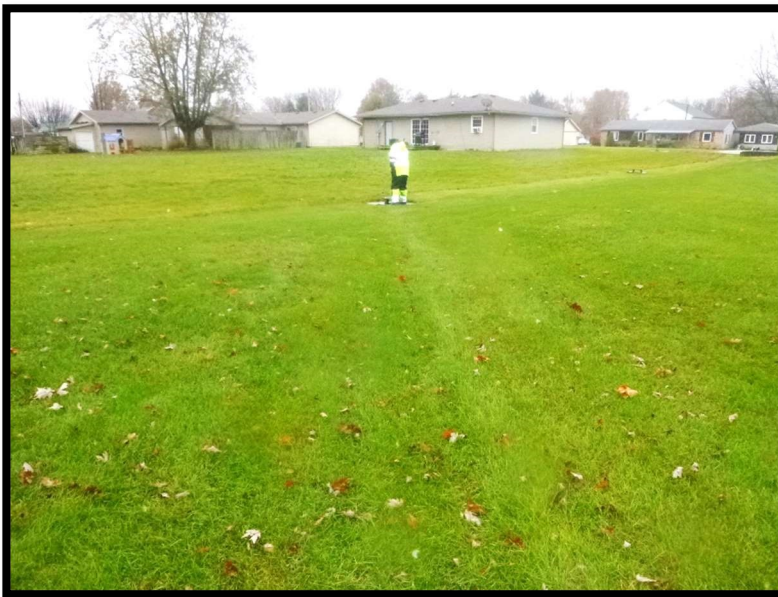
**Photo No. 92**

In backyard along storm  
sewer path, standing in  
swale line running parallel
